THE 35TH ANNUAL
AGC NYS
 INDUSTRY CONFERENCE

How The Towers Fell – Part 1/3
 How the WTC Twin Towers Were Constructed &
 Lessons Learned From the 1993 Bombing

Joe Englot, PE
 HNTB Corporation

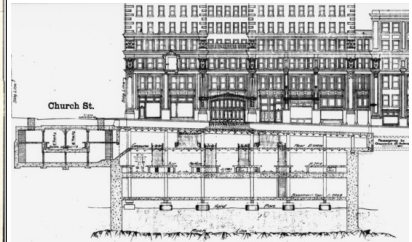
Cross Section of H&M Terminal Station Platforms Below Building Looking South

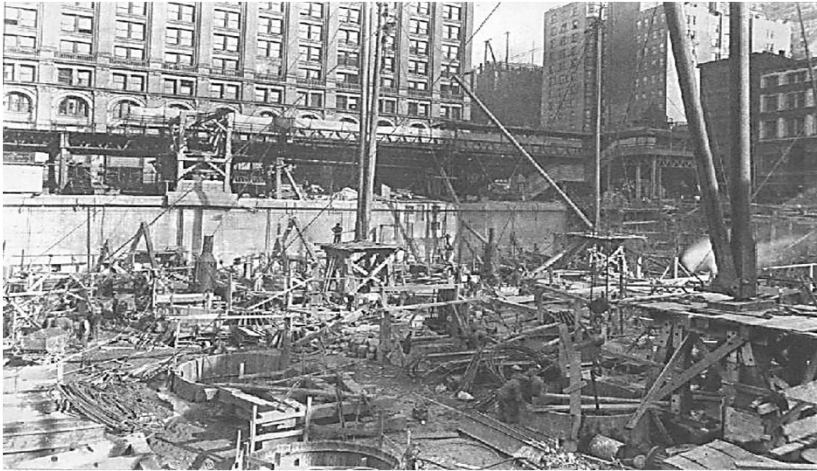
- Photo shows 1906 top-down construction to bedrock of the H&M building basement and foundations
- Space housed the Cortlandt St. Station of the H&M Terminal
- This space was to later become WTC basement truck loading dock
- The Elevated 6th Avenue Subway on Church Street is in the background
- Elevated line was to be taken down after a new underground subway line (now called N & R line) was constructed below church street & directly connected to the new H&M Terminal Station

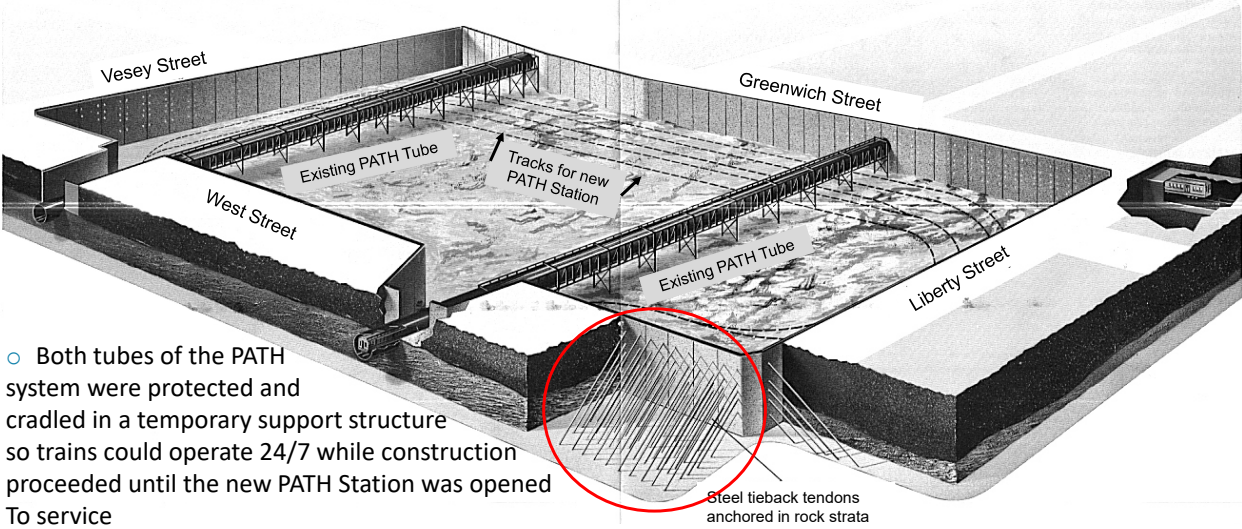
- Both tubes of the PATH system were protected and cradled in a temporary support structure so trains could operate 24/7 while construction proceeded until the new PATH Station was opened To service

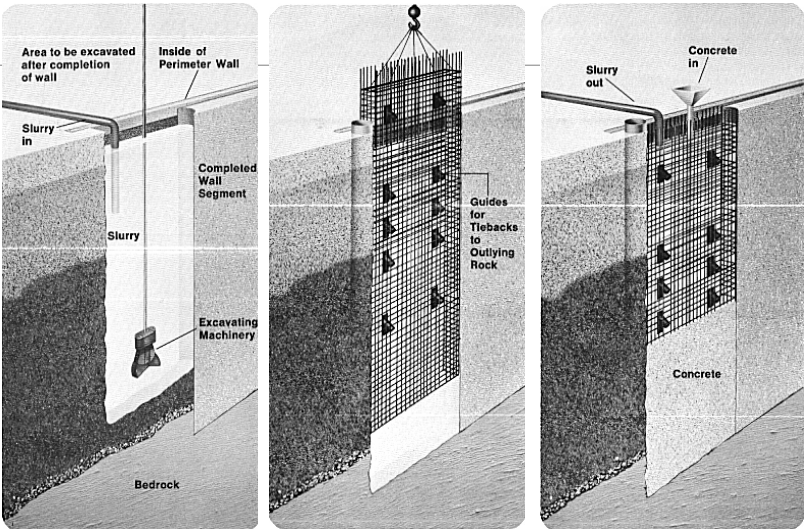
- The **slurry wall method** of retaining wall construction was used in the United States for the first time
- Dense Bentonite slurry is pumped into the excavation as soil is removed to exert fluid pressure to hold back the earth
- A steel rebar cage is lowered into the excavated hole
- Concrete is pumped into the excavated hole to displace the slurry which is pumped out
- As the inside of the new concrete retaining wall is excavated, soil anchors are installed to hold back the earth pressure

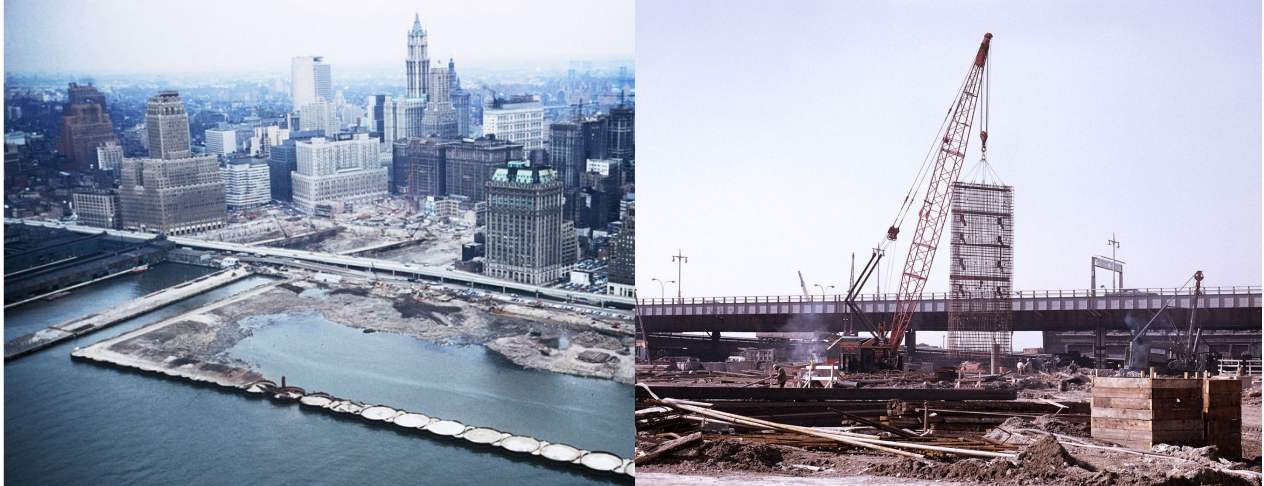
- Circular coffer dams were used to create a bulkhead to retain the large quantity of excavated soil in the land fill
- Crane lifting a rebar cage that was prefabricated to lower it into an excavation stabilized by Bentonite slurry

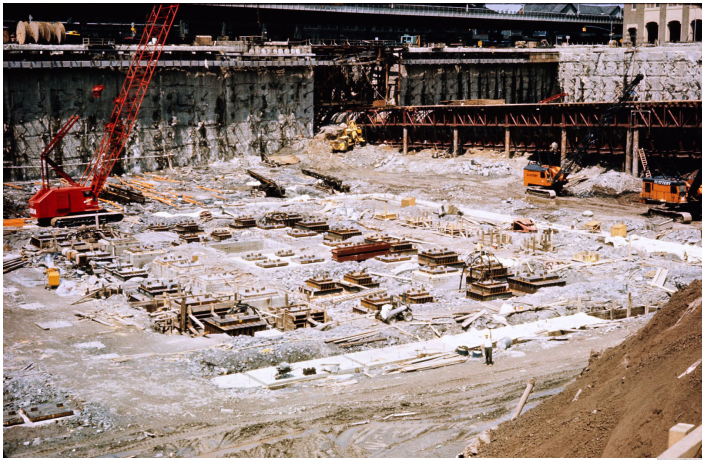
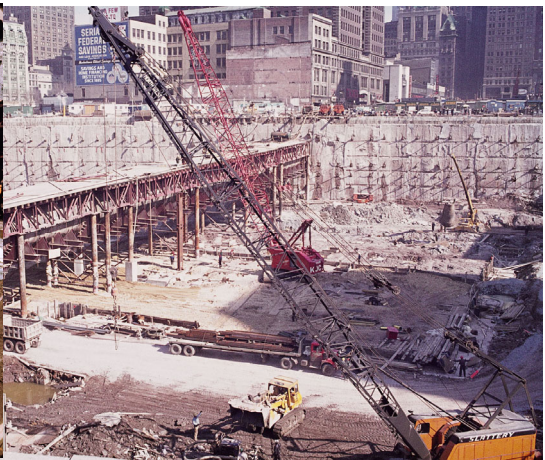
- The foundations for the 1 WTC Tower are shown under construction. They consisted of structural steel grillages founded directly on bedrock. The NJ-bound PATH line is in the background.
- View of the retaining wall at Greenwich St. which supported the excavation to a depth of six stories below street level. Here the old PATH line crosses under the 1 & 9 Subway line. Both lines remained in operation.

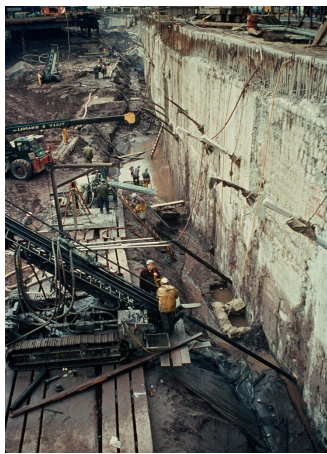
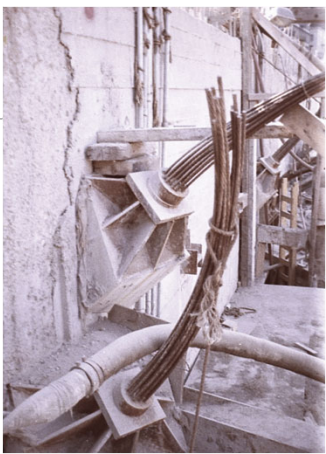
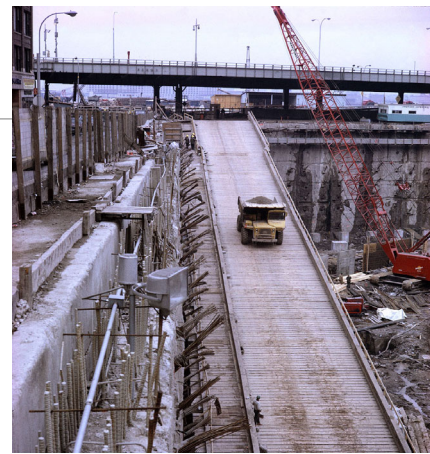
- Tiebacks (left and center) consisting of high strength steel cable strands were jacked and then anchored with wedges to provide the prestressed lateral force to hold back the earth after wall was excavated to full depth.
- The tiebacks extended beneath adjacent properties or city streets and were considered temporary. Upon completion of the interior diaphragm slabs of the WTC basement which would be permanently relied upon to brace the walls they were decommissioned by removing the anchor heads.
- Right, a construction access ramp from West Street to provide access for heavy equipment as the excavation gets deeper.

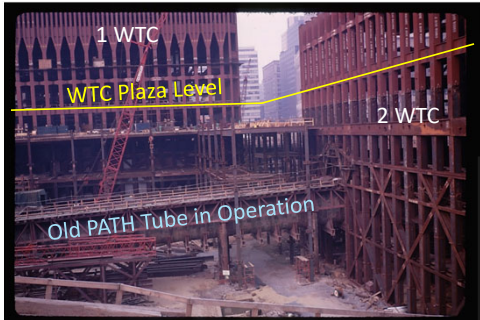
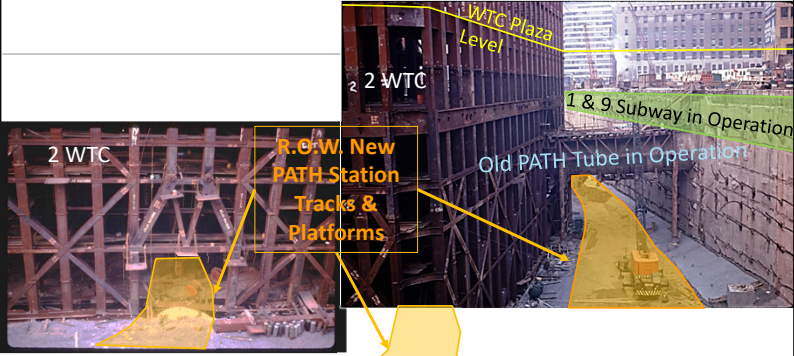
- o Photo above shows logistics and staging required to maintain the old existing PATH/H&M operations going during construction of the new WTC Towers 1 and 2. The existing train tunnel passed through Tower 2 on right at the B-5 & B-4 basement level.
- o Above center we see the new PATH station track alignment which passes through and under Tower 2 at the B-6 basement level in center (above) and at the tower corner (right).
- o The right side also shows logistics and staging to work around both the existing PATH and 1 & 9 Subway operations behind the slurry wall during construction and below the new WTC Plaza level

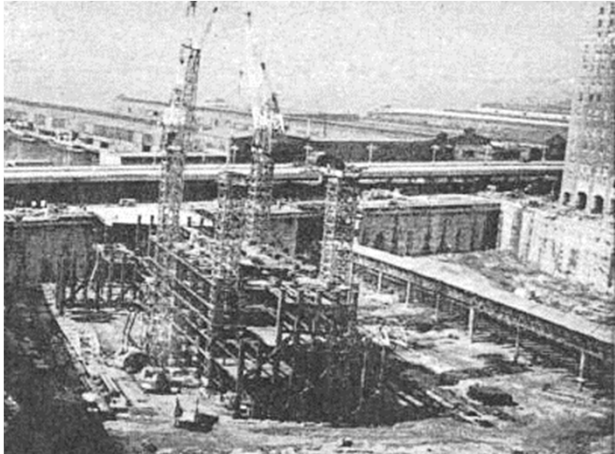
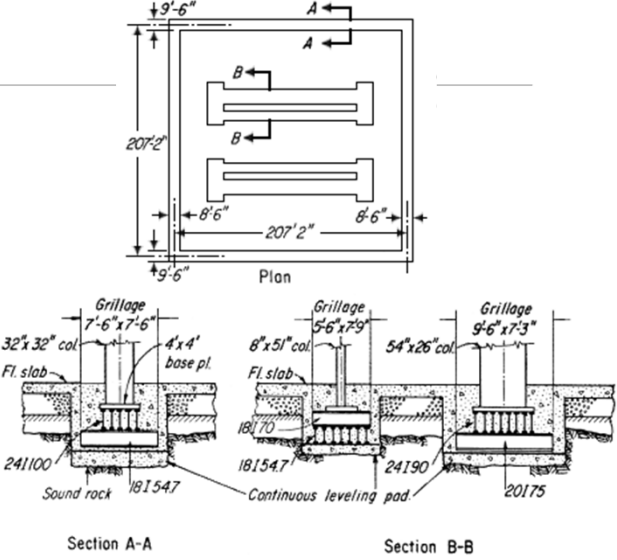
- o Above: Tower 1 Steel Erection Begins starting with the core which supports the Kangaroo Cranes that will advance by jacking upward to erect all steel and prefabricated floor systems & exterior cladding
- o Right: Foundation Plan, Core and Perimeter Column Steel Grillages

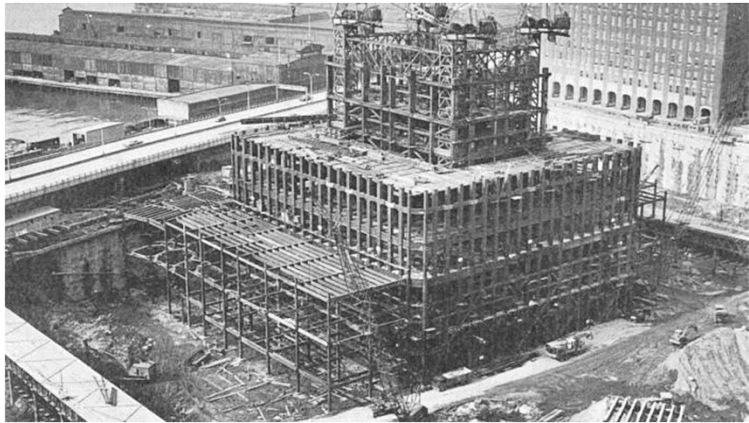
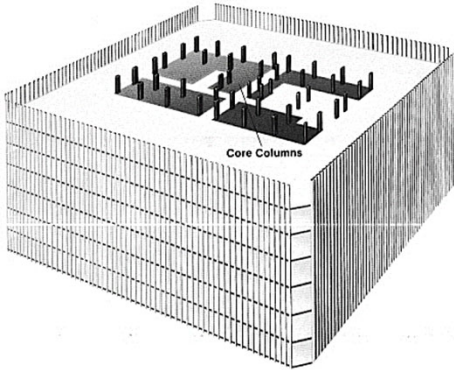
- Tower 1 erection of core followed by erection of steel perimeter “tree” columns and prefabricated deck elements made from long span joists followed by erection of steel supporting the plaza up to the concourse level.

- The Wall and Core: Typical tower floor provided almost an acre of unobstructed office space on each floor with the outer **load bearing wall forming a giant tube structure** that provided lateral stability and stiffness to resist wind loads with up to a 10,000-year return period.

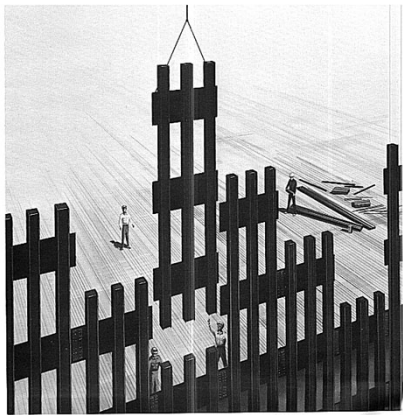
- Above: The tower perimeter load bearing wall was erected with prefabricated panels with vertical columns shop welded to horizontal spandrels. The unit shown weighs 22 tons and is 36 feet tall and 10 feet wide.

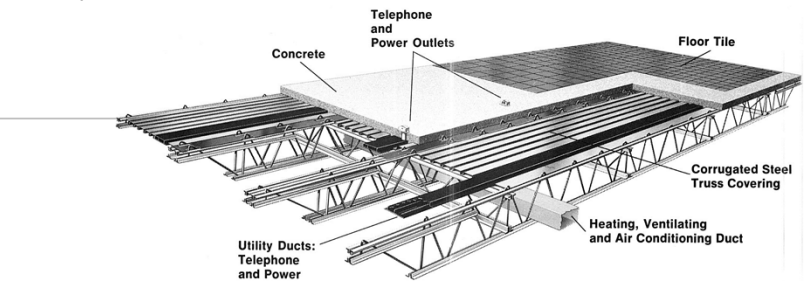
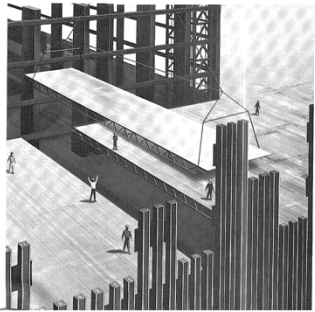
- Above: The floor panels are prefabricated with supporting long span steel truss joists and corrugated steel deck. Utility chases and air conditioning ducts are within the 32-inch deep ceiling space. The concrete slab, floor tile, ceiling tracks and ceiling tile are installed on site.
- Left: Floor Framing: Typical prefabricated floor panel is 60 ft. by 13 ft. and is lowered into place after the load bearing wall is constructed behind the core columns.

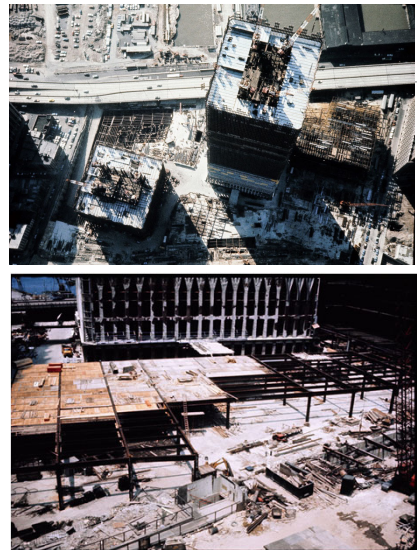
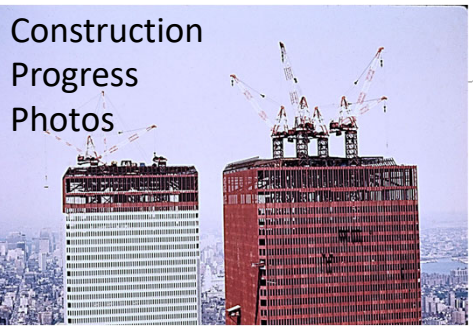
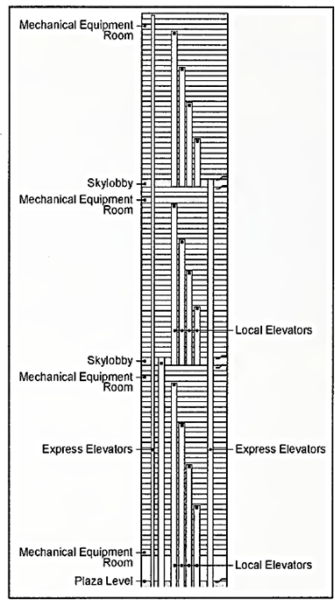
Construction Progress Photos

- Upper left: Note the tower cores oriented at 90 degrees to each other to avoid sympathetic behavior with wind load vortex shedding effects
- Right: The WTC's **Innovative Elevator System** optimized the use of the Core Space in the Towers and expedited elevator travel by utilizing both Express and Local Elevators. The 3 different banks of local elevators occupied the same vertical shaft space in the tower core.

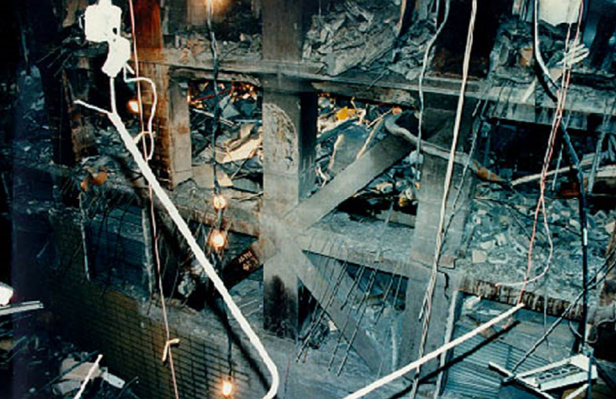
Findings for 1993 Bombing of WTC Complex:
 On Friday, February 26, 1993, a violent explosion
 ripped through a parking garage in the sub-
 basement levels of New York's World Trade
 Center . In excess of 1,000 TNT equivalent.

B-2 Level Damaged Tower Column and Missing Bracing Member

B-2 Level Damaged Tower Column and Missing Bracing Member

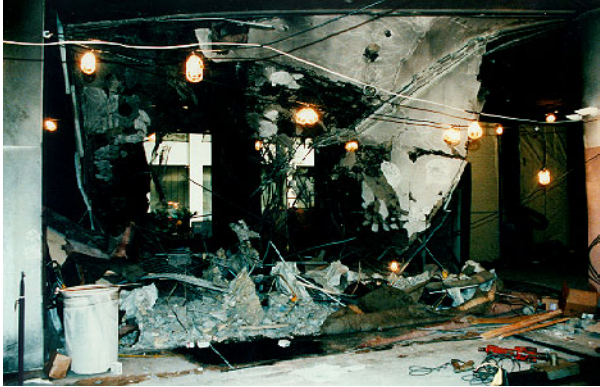
Damage at the WTC Concourse Level (Main Lobby Elevators in 1 WTC Seen in Distance). The Blast Vented Upward Through the Hole in the Floor. (The WTC Plaza Slab Above this Level Buckled Upward but Did Not Breach)

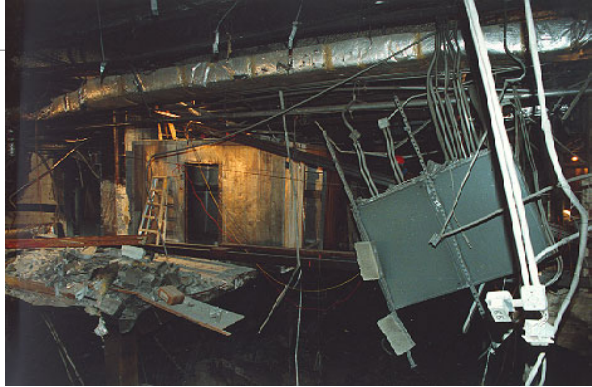
Damage at the B-1 Level Where the Was a Large Section of Floor Slab that Collapsed Adjacent to the Operations and Control Center

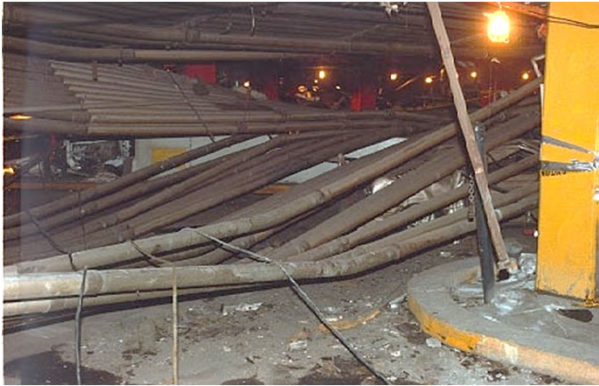
Collapse of Utilities from Blast at B-2 Level
NY Telephone Company major telephone exchange at the WTC complex providing telephone service to Lower Manhattan also providing service for air traffic control systems at the three major NY-NJ airports

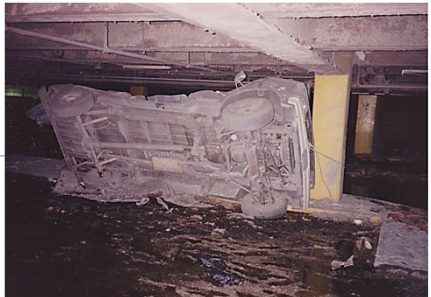
Vehicle at B-2 Level Overturned by Blast Pressure

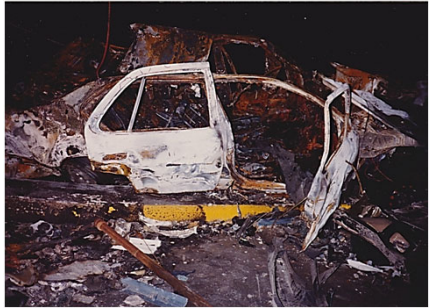
Remains of Burning Vehicle at the B-2 Level

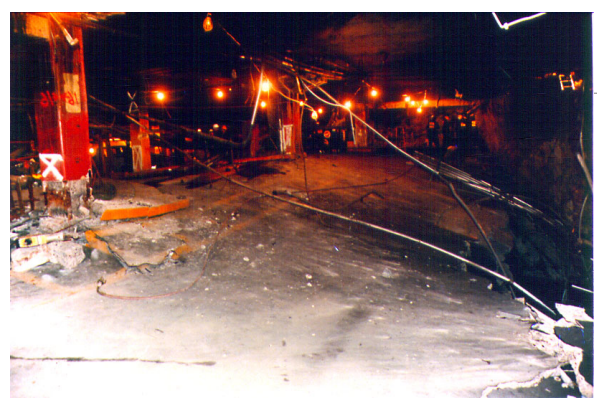
Sloping Edge of the Bomb Crater at B-2 Level

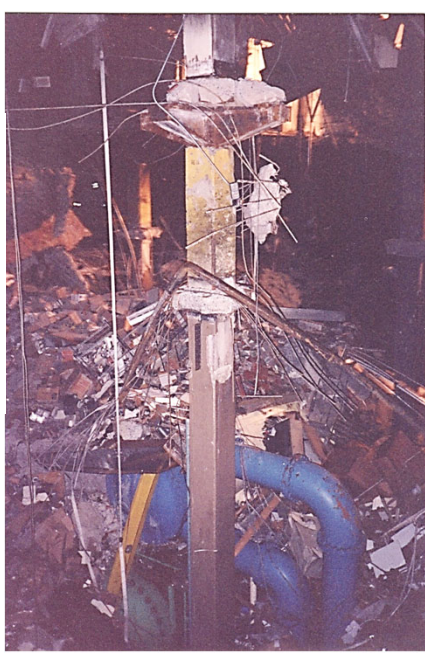
4- Story Tall
Unbraced
Column in the
Center of the
Crater Created
by the Bomb
with Some
Also
Supporting
Vista Hotel

Out of Concern for the Stability of the 4-Story-Tall Unbraced Columns in the "Crater" Steel Bracing Members Were Designed and Installed Before the Debris at the Bottom of "Crater" Was Removed. The Debris May Have Been Stabilizing the Columns.

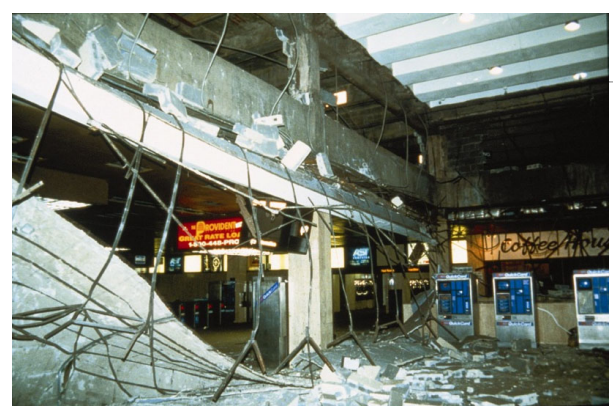
Collapse of Parking Garage Walls & Finishes
From B-3 Level Fall onto the PATH Station Fare
Collection Zone on B-4 Level

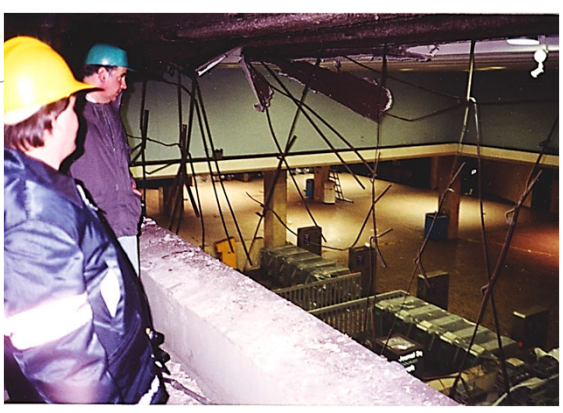
Looking Down on B-4 Level PATH Fare Zone
From B-3 Level After Debris Clean Up. PATH System was
Found to be Operable.

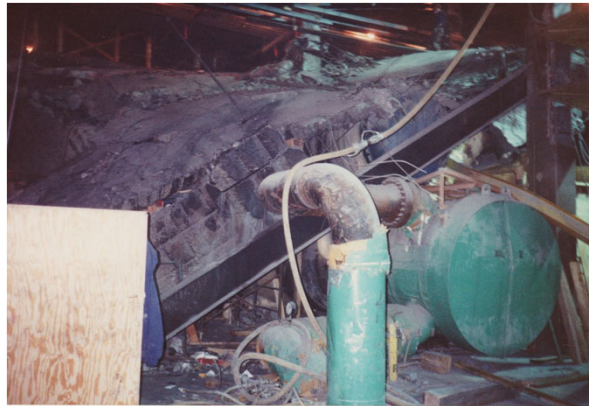
Fire Charred Concrete Floor Slabs and Collapsed Steel Framing Lying on Top of the Refrigeration Equipment (Chillers and Piping) at Bottom of Crater at B-5 Level

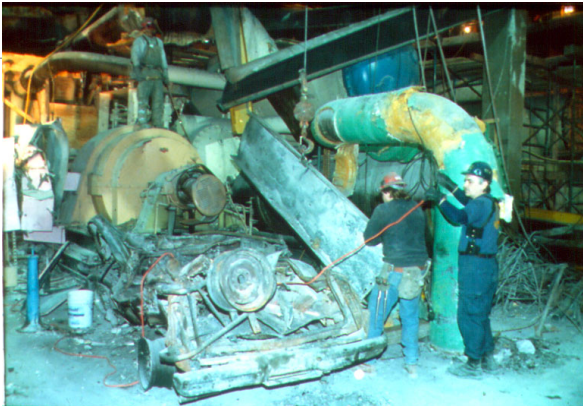
Chassis of Blast Damaged Vehicle and Collapsed Steel Framing Lying on Top of the Refrigeration Plant

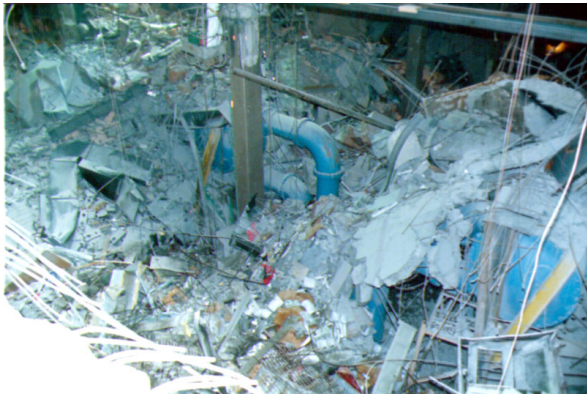
Collapsed Slabs from the B-1 and B-2 Levels Crushed the Refrigeration Plant Equipment on the B-5 Level

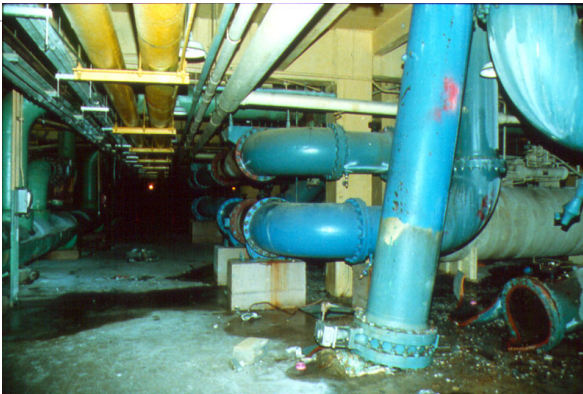
Damaged Piping at the B-6 Level that Supplied Hudson River Water as Coolant to the Chillers Created Flooding of the B-6 Level Where the Emergency Generators Overheated

- Emergency generator in the basement shut down causing complete power electric failure to towers and elevators
- Generators shut down due to overheating since cooling system piping was ruptured by collapse

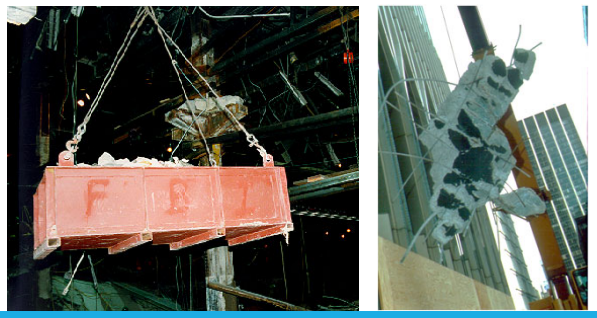
Damaged Sidewalk Slab at Plaza Level Removed (top) to Hoist and Load Debris on Trucks to FBI Inspection Site
