THE 35TH ANNUAL
AGC NYS
INDUSTRY CONFERENCE

How The Towers Fell – Part 2/3 WTC Twin Towers and Seven WTC Collapse from the 9-11 Attacks

Joe Englot, PE
HNTB Corporation

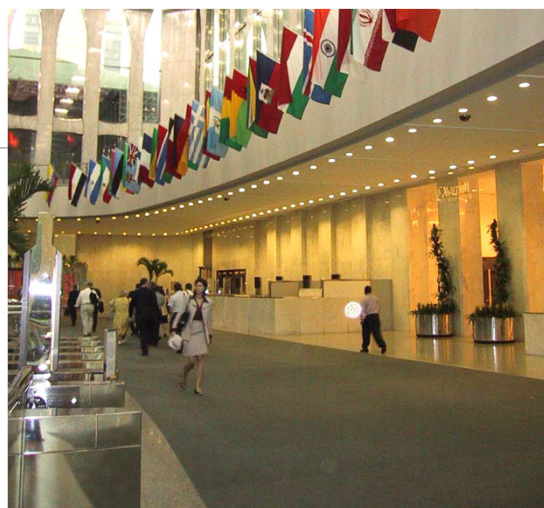
Visitor Security Desk at WTC Tower Lobby Shown at Right and Turnstile Barrier Shown at Left

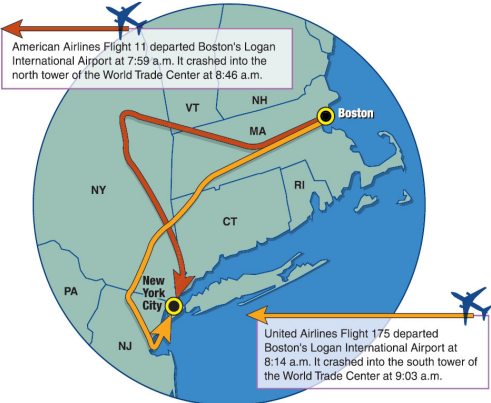
Approximate Path of Hijacked Plane Flights Shown at Left and Tower Impacts Shown at Right

- Both flights, destined for Los Angeles, were Boeing 767-200ER series aircraft loaded with fuel
- The estimated speed of impact:
 - North Tower: 410 knots (470 mph)
 - South Tower: 510 knots (590 mph)
- The floors with physical impact damage:
 - North Tower: 94th to 98th Floors
 - South Tower: 78th to 84th Floors
- The impact locations:
 - North Tower: Near center at slight tilt of wings
 - South Tower: Off center toward East at significant angle and tilt of wings
- The damage to far side of tower:
 - North Tower: Landing gear penetrated south face
 - South Tower: Landing gear, fuselage section and engine penetrated north face near east corner

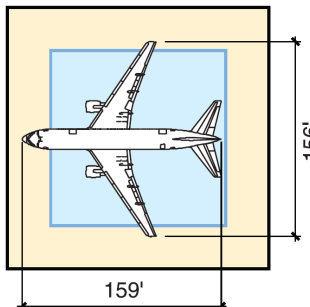
B767-200ER

- 395,000 lb. Maximum Takeoff Wt.
- 23,000 gal. Maximum Fuel Capacity
- 607 mph. Cruising Speed

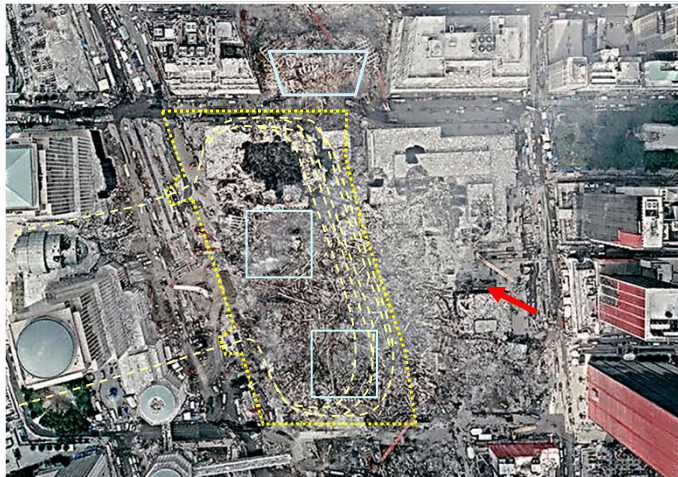
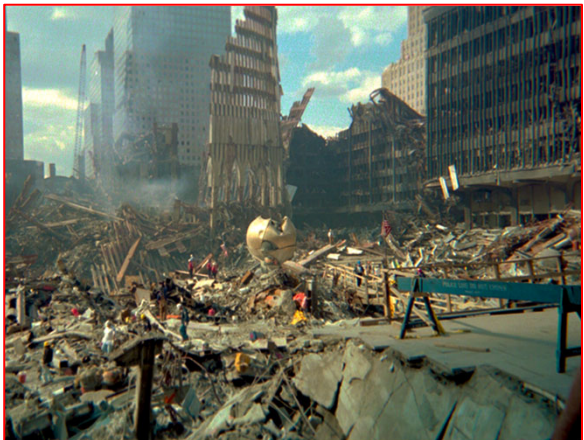
Plaza Collapsed Looking West With Fountain And Remains of Tower 1 Beyond

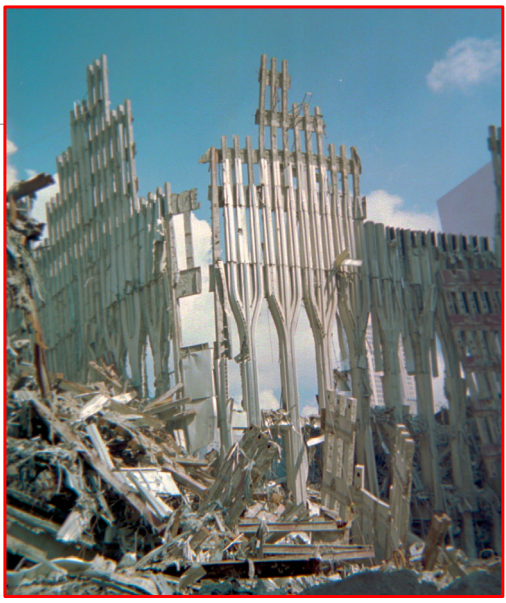
Remains Of Tower 2 Facade Columns Viewed From Liberty St. At Corner Of West St.

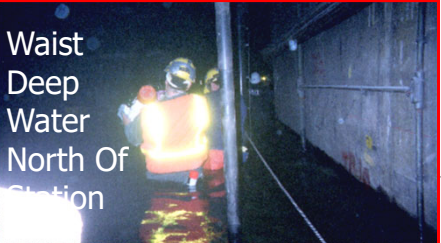
PATH WTC Station: Platform And Track Level

Waist Deep Water North Of Station

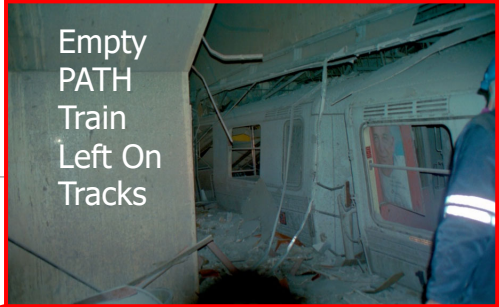
Empty PATH Train Left On Tracks

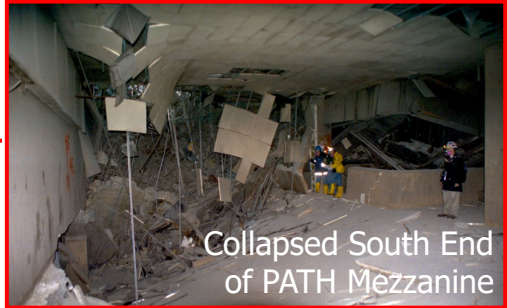
Collapsed South End of PATH Mezzanine

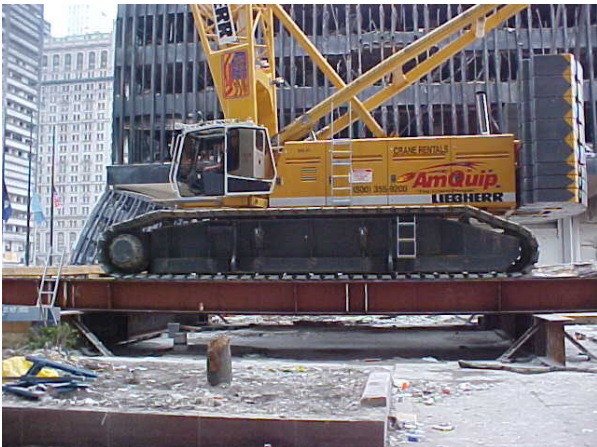
Sept 20, 2001 (Day 9) : Grillage was placed to support 310-ton crane, placed above concourse level, between Bldgs. 4 & 5. Northeast Plaza Building (Bldg. 5) in background.

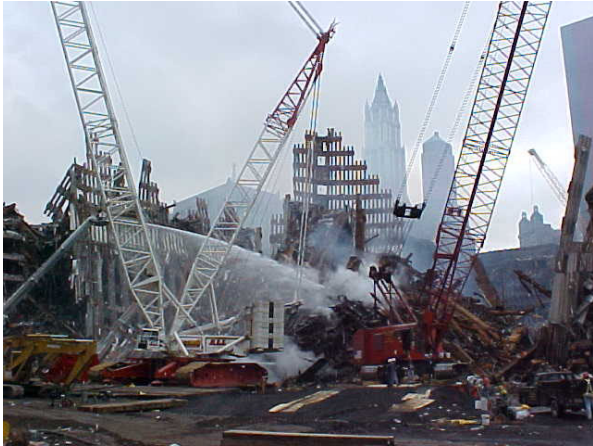
Sept 26, 2001 (Day 15): Tower 1 still burning. Sub-basement 6 flooded. Temperature at sub-basement 5 measured at 1,200 degrees F. Sub-basements 4, 3, 2, & 1 collapsed. Site is changing from recovery to a demolition project.

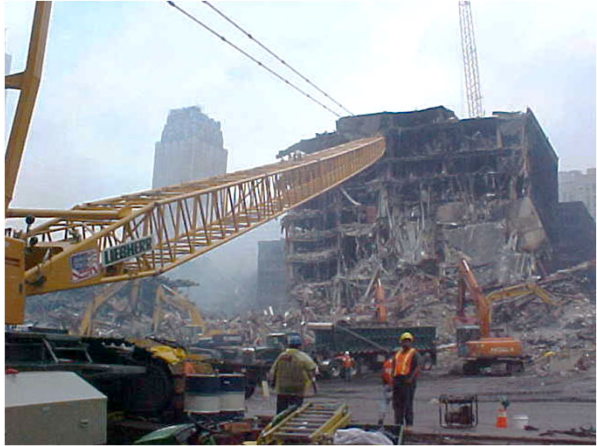
Sept 26, 2001 (Day 15): Demolition of Southeast Plaza (Bldg. 4) begins.

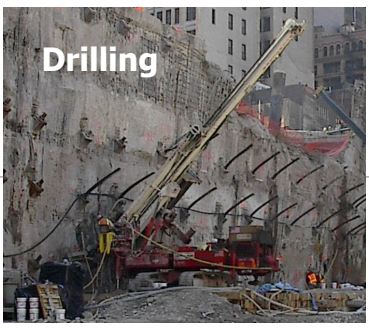
Drilling

- Strand anchors, with corrosion protection
- Strand bundles are set in a hole drilled into bedrock (~30 ft)
- Bundles have grout hose attached to them
- Cement grout tremied from the bottom of bundle to top of the casing
- After grout set (2 to 3 days) the tendons were tensioned

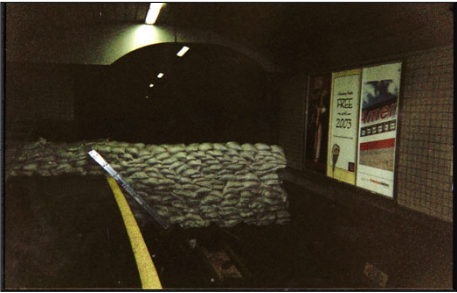
Right: Sandbags Installed when inflow of water at PATH Exchange Place Station track level began to exceed the pumping capacity

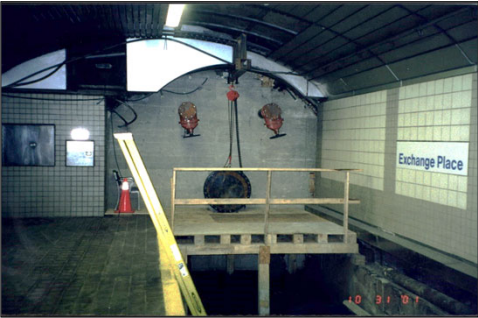
Left: Placement of formwork for a concrete plug with sealable person access door (large pipe with bolted flange cover). Right: completed plug.

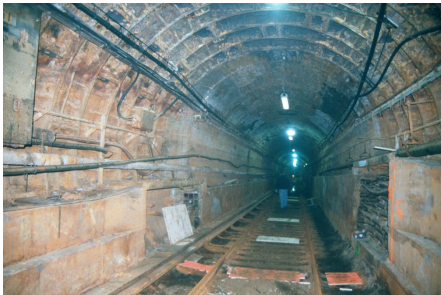
Deteriorated Duct Bank Cables at Splice Chamber

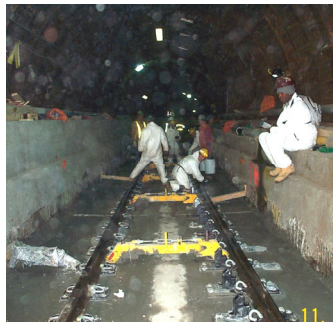
- 1. Deteriorated electrical duct banks were removed, new ducts installed, and concrete formed
- 2. Deteriorated track bed removed and new concrete duct banks cast
- 3. Installation of direct fixation concrete track bed and rails.

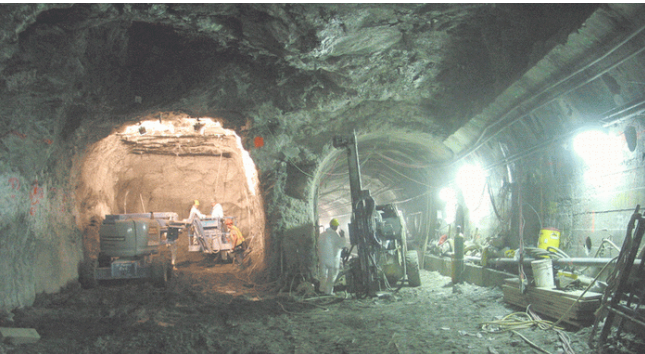
Above: Installing Rock Anchors In Newly Mined Tunnel Cross-section

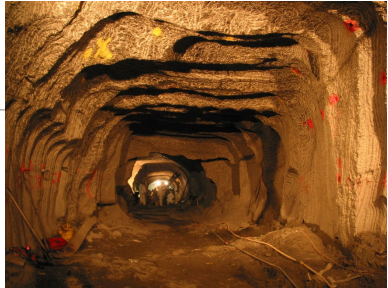
Right: Tunnel Mined in Mica Schist Rock

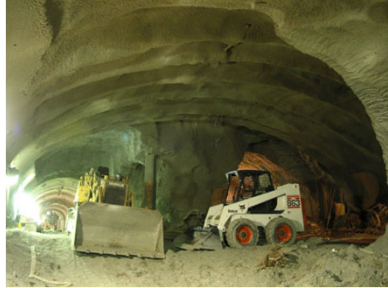
Right: Installation of Lattice Support Girders with Shotcrete

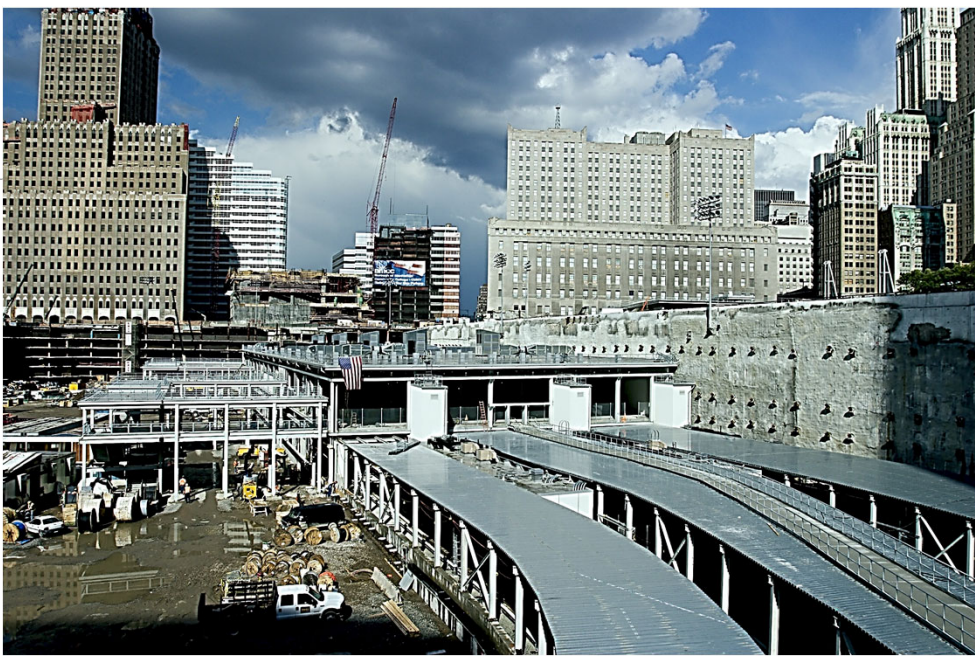
Temporary PATH Station – Steel Erection

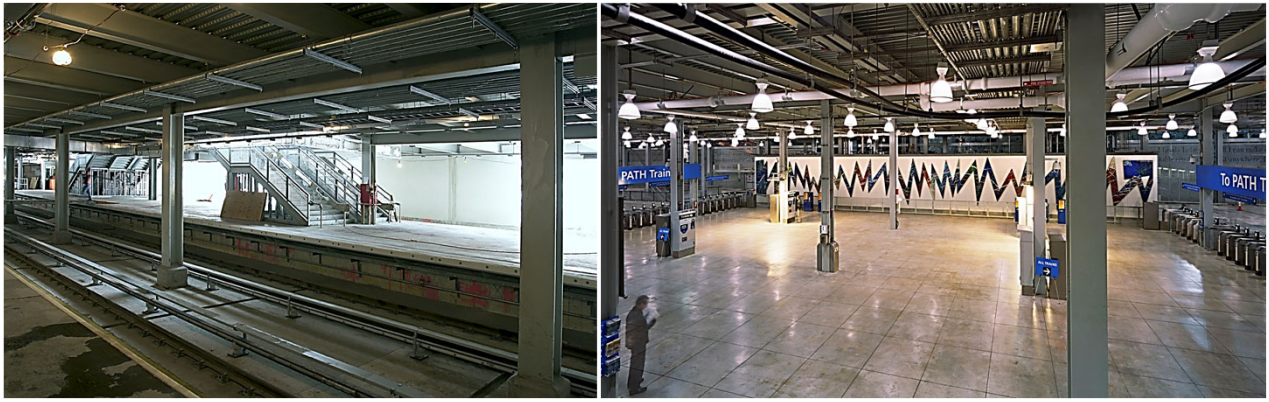
Platform/Track Level

Fare Zone/ Mezzanine Level

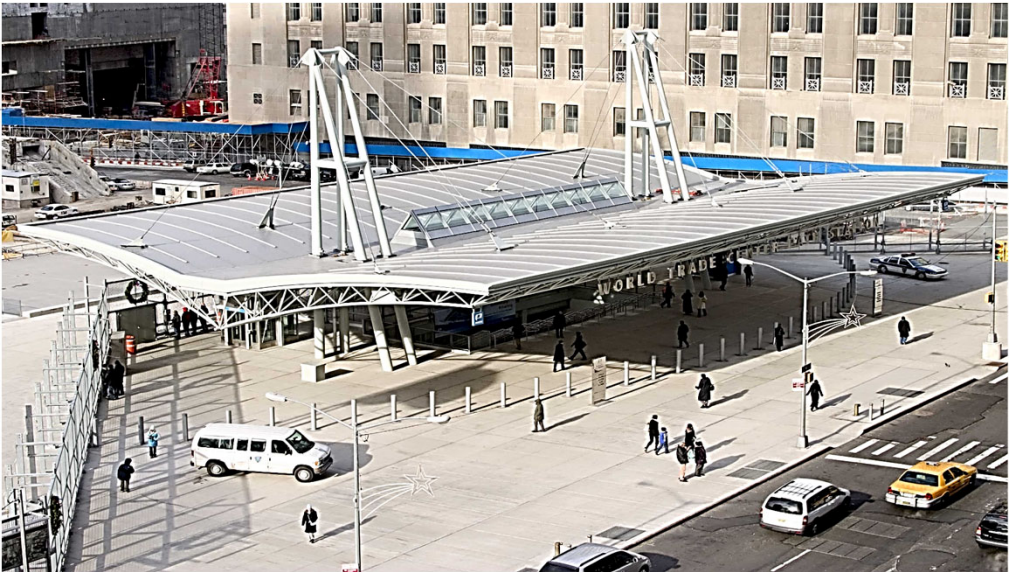
Temporary PATH Station Church Street Entrance Canopy
